Haukadalsbót, Arctic Sea Farm
B-bottom survey,
August 2021
(maximum biomass survey)

Information client			
Title	Haukadalsbót, Arctic Sea Farm. B-bottom survey, August 2021		
Report number	APN-63315.B01		
Site name	Haukadalsbót	Coordinates site	65°53.342 N 23°35.871 V
County	Ísafjarðabær	Municipality	Pingeyri
MTB-or estimated max biomass	5.000 ton	Site manager/contact	Steinunn Guðný Einarsdóttir
Client name	Arctic Sea Farm

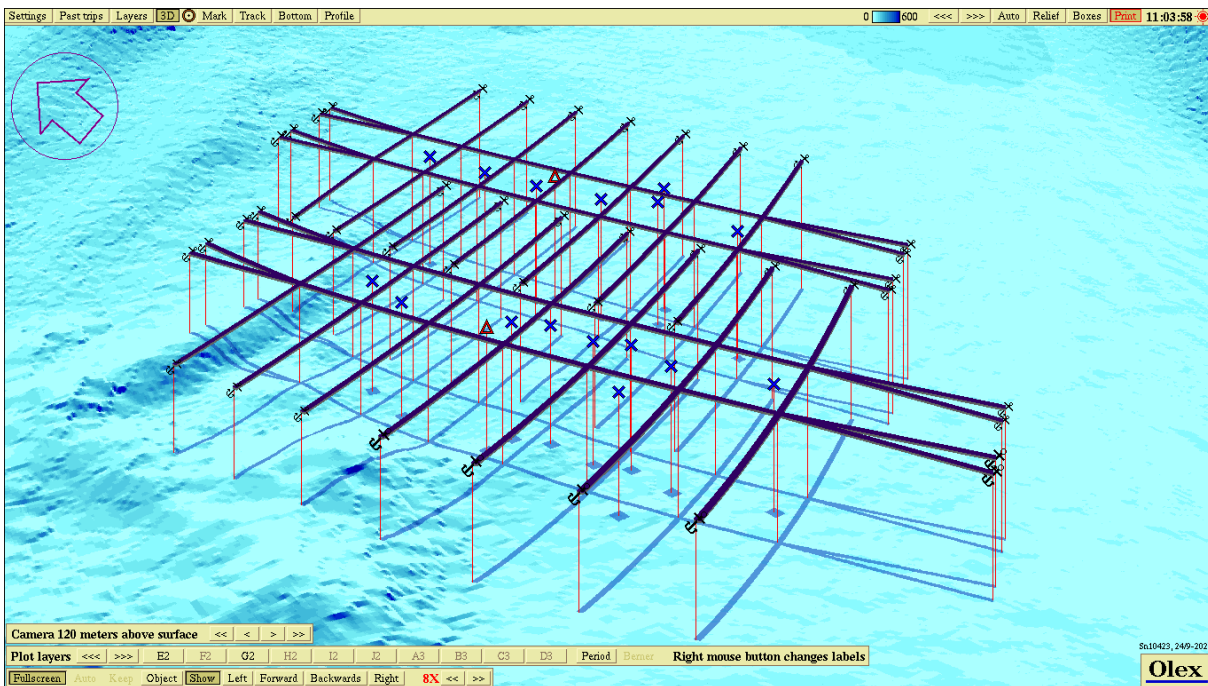
Figure 3. Showing bottom topography 3D at Haukadalsbót with each sampling station according to info in figure 2 and Table 3.
