Kvígindisdalur, Arctic Sea Farm
B-bottom survey,
November 2020
(maximum biomass survey)

Information client			
Title	Kvígindisdalur, Arctic Sea Farm. B-bottom survey, November 2020		
Report number	APN-62579.B01		
Site name	Kvígindisdalur	Coordinates site	65°34.665 N 024°02.222 V
County	Vesturbyggð	Municipality	Patreksfjörður
MTB-or estimated max biomass	4.850 ton	Site manager/contact	Steinunn G. Einarsdóttir
Client name	Arctic Sea Farm

Results from B-survey iht. NS 9410:2016 (main results)			
Parameters and indexes		Parameters and site status	
Gr. II. pH/Eh	1,47	Gr. II. pH/Eh	2
Gr. III. Sensory	1,01	Gr. III. Sensory	1
GR. II + III	1,24	GR. II+ III	2
Date field work	10.11 2020	Date report	16.12.2020
Site status (NS 9410:2016):			2

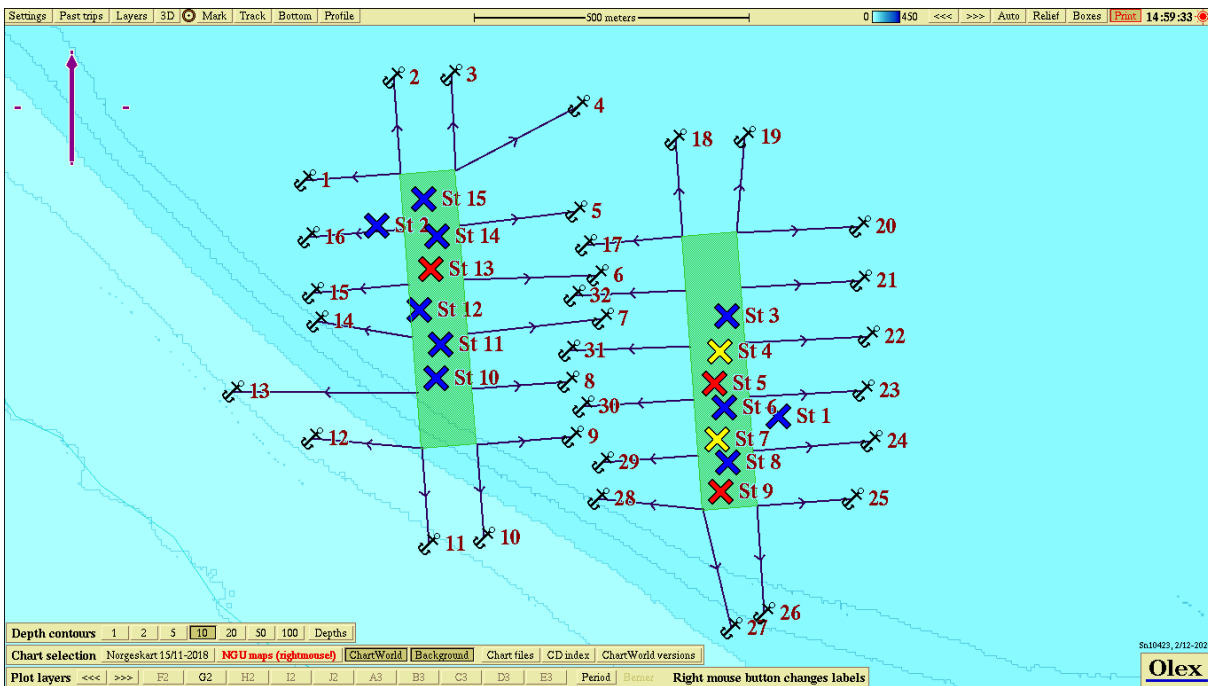
Figure 2. Chart showing depths at the site Kvígingisdalur. Sampling stations st. 1 – 15 are marked with color codes that describe the condition according to NS 9410:2016, chapter 7.11. Color codes: Blue = very good condition, green = good condition, yellow = bad condition, red = very bad condition.

Description of the 15 stations in the survey is given in figure 2 and table 4. Positioning of the stations was chosen based on guidance and perimeters described in NS 9410:2016 and spread around the periphery of the cages. At the Kvígingisdalur site the typical depth in the local impact zone is in the range from 35 – 58 m, with the shallowest parts in the south-west part (closest to land) and more depth in direction into the middle of the fjord. The placement of sampling stations was chosen to give a good picture of the condition of the whole local impact zone. It is important to evaluate the status in both the deeper and shallower parts of the local impact zone of the fish

farm. The sampling stations had a depth varying from 55 to 58 m. The placement of the sampling stations is regarded to be in accordance with the descriptions for survey of local impact zone given in NS 9410:2016.

For combined parameters II and III (pH/redox and sensory) ten stations had status 1 «very good», two stations had condition «good», three stations had condition «bad» and three station had condition «very bad» (stations 5, 9 and 13). The stations with bad and very bad conditions were mainly located at the eastern part of the fish farming area and overall the condition was better at the western part of the site. The accumulation of organic material seems therefore to be more accumulated at the eastern part of the fish farming area coherent with the direction of the spread current for the site in SSE direction (165 degrees). Three stations had some gas bubbles noted in the sample (stations 3, 11 and 14). Animals were present in all soft bottom samples. The results indicate some organic load at the Kvígingisdalur site that has accumulated in the local impact zone during the this first production cycle. The previous B survey before putting smolt into sea gave overall condition 1 «very good». In the next B survey close attention should be given to the areas in the eastern part of the local impact zone.
